AEROSPACE REPORT NO.
TR-0089(4935-08)-1

An Investigation of the Effect of Low Velocity Impacts on P75/934 Graphite/Epoxy Composites

J. N. SCHURR, M. T. QUINN, and G. F. HAWKINS
Materials Sciences Laboratory
Laboratory Operations

1 April 1991

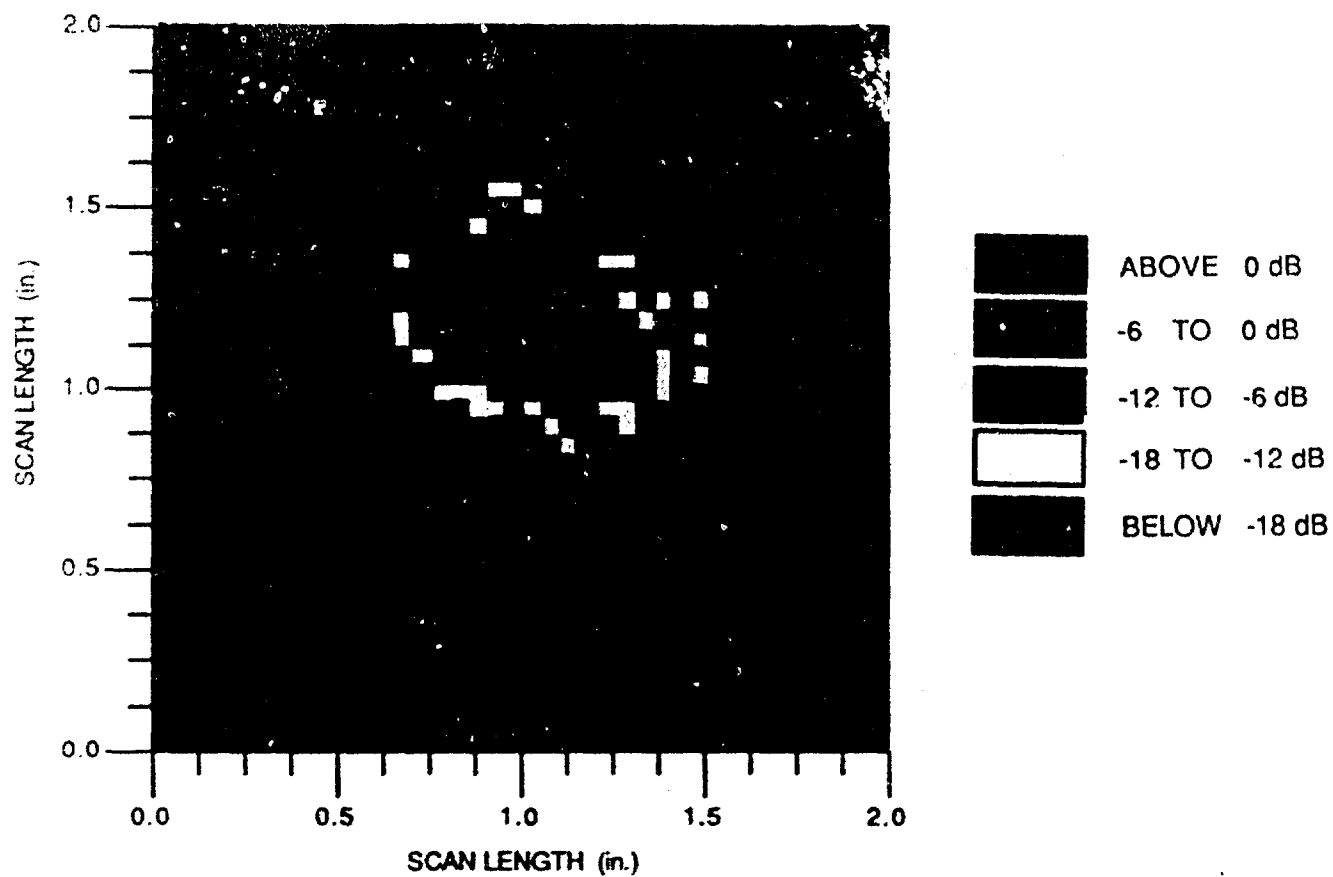
Fig. 16. Detailed Scan of Damaged Area in NDT-6.11. Note the similarity in shape of the damaged area to that revealed with radiopaque dye (see Fig. 10).

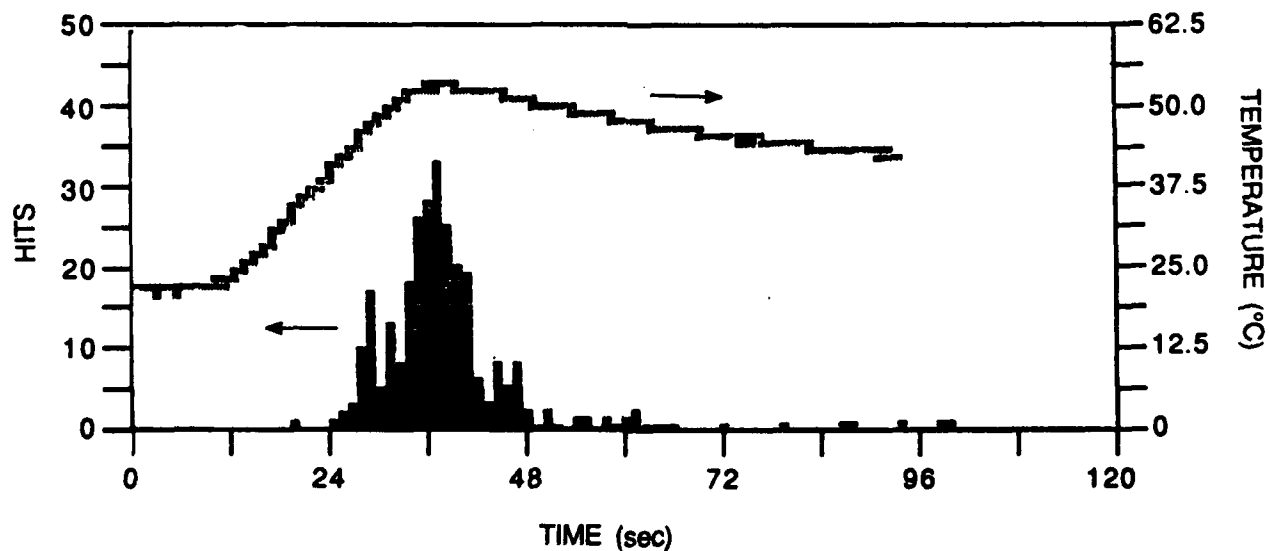
The first run was made on an undamaged specimen cut from NDT-4. The results are graphed in Fig. 18. As expected, no notable AE was detected from the undamaged specimen. When a damaged specimen was tested, AE increased with increased temperature. In their work with carbon-carbon composites, G. F Hawkins et al. attributed the increase in AE signal to the increase in thermal strain caused by the larger thermal gradient (Ref. 16). The results from NDT-4.11 are shown in Fig. 19. The AE data from the four specimens tested indicate an inverse relationship between number of events and impact energy. Also, the amplitude of each event increased with increasing impact energy.

Fig. 19. Acoustic Emission from Specimen NDT-4.11. Total number of hits: 1005. Impact energy of 24.0 in.-lb.

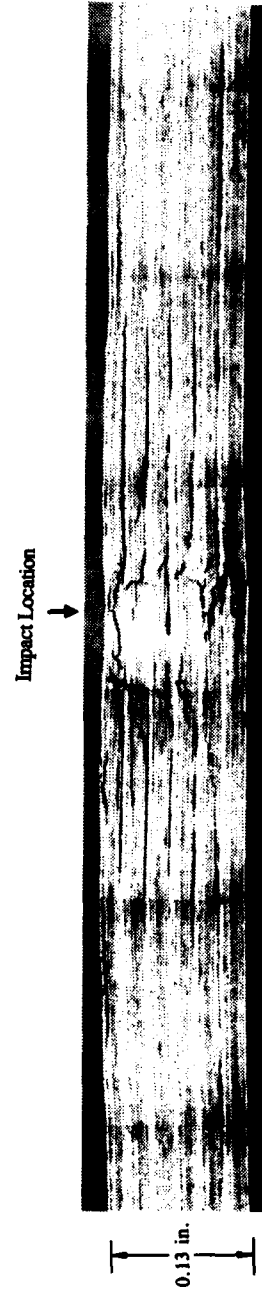
One impacted specimen, NDT-6.11, was set aside for cross sectioning and deply analysis. NDT-6.11 was cut into three sections through the impact-damaged area using a diamond wire saw. Two of the sections were mounted and polished with one section polished along the 90° normal and the other section along the 0° normal. Figure 20 reveals the polished cross section of the 90° normal section. Recall that the bag side of the laminate was impacted, and therefore ply No. 1 is on the side opposite the impact. Major delaminations could be seen between every 0 and +52° ply sequence except the first one. These delaminations extended about 1/2 in. to each side of the impactor contact point. The size of these delaminations correlates well with the ultrasonic C-scan and X-ray assessment of the damage size. Delaminations were also visible between many +52 and -52° plies and some -52 and 90° plies. Fiber breakage and matrix cracks were found throughout the thickness of the specimen but were confined mainly to just below the point of impact. The polished cross section of the 0° normal section revealed results similar to those found in the 90° normal section.

Fig. 20. Photomicrograph of the Cross Section of NDT-6.11 After Impact

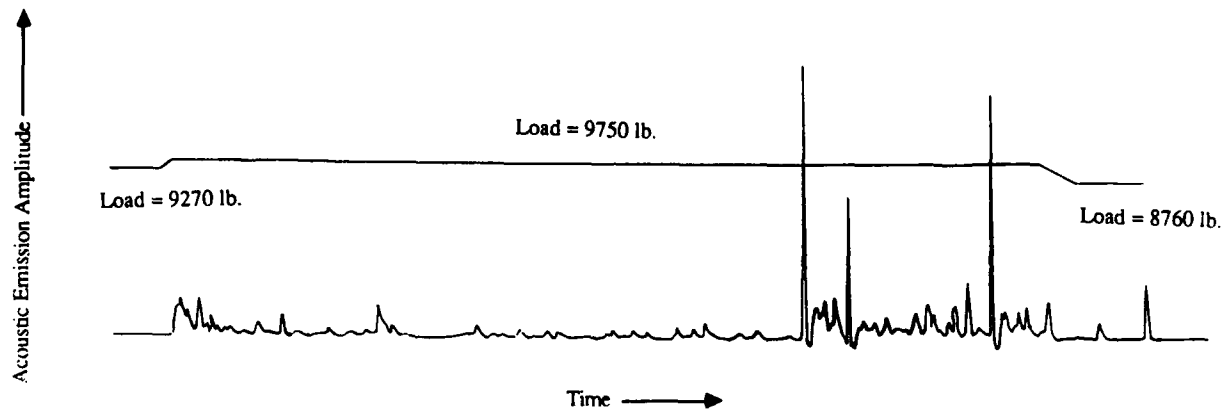
From the AE data, it appears that starting from 9750 lb, significant damage was occurring in the specimen and might have continued to failure if the load had not been reduced. Other researchers have found that, for a carbon-carbon part, AE occurred during load reductions if the part was damaged (Ref. 20). Although the NDT specimens are Gr/Ep composites, as opposed to carbon-carbon, it is interesting to note that for NDT-4.11, no AE occurred during load reductions until after the second 9750 lb hold even though it was already impact damaged.

Fig. 22. Acoustic Emission of NDT-4.11 During Compression Loading
